THE GREAT ALASKA EARTHQUAKE

Volume II

Illustrations and Maps

TECHNICAL REPORT NO. AFWL-TR-65-92, Vol II

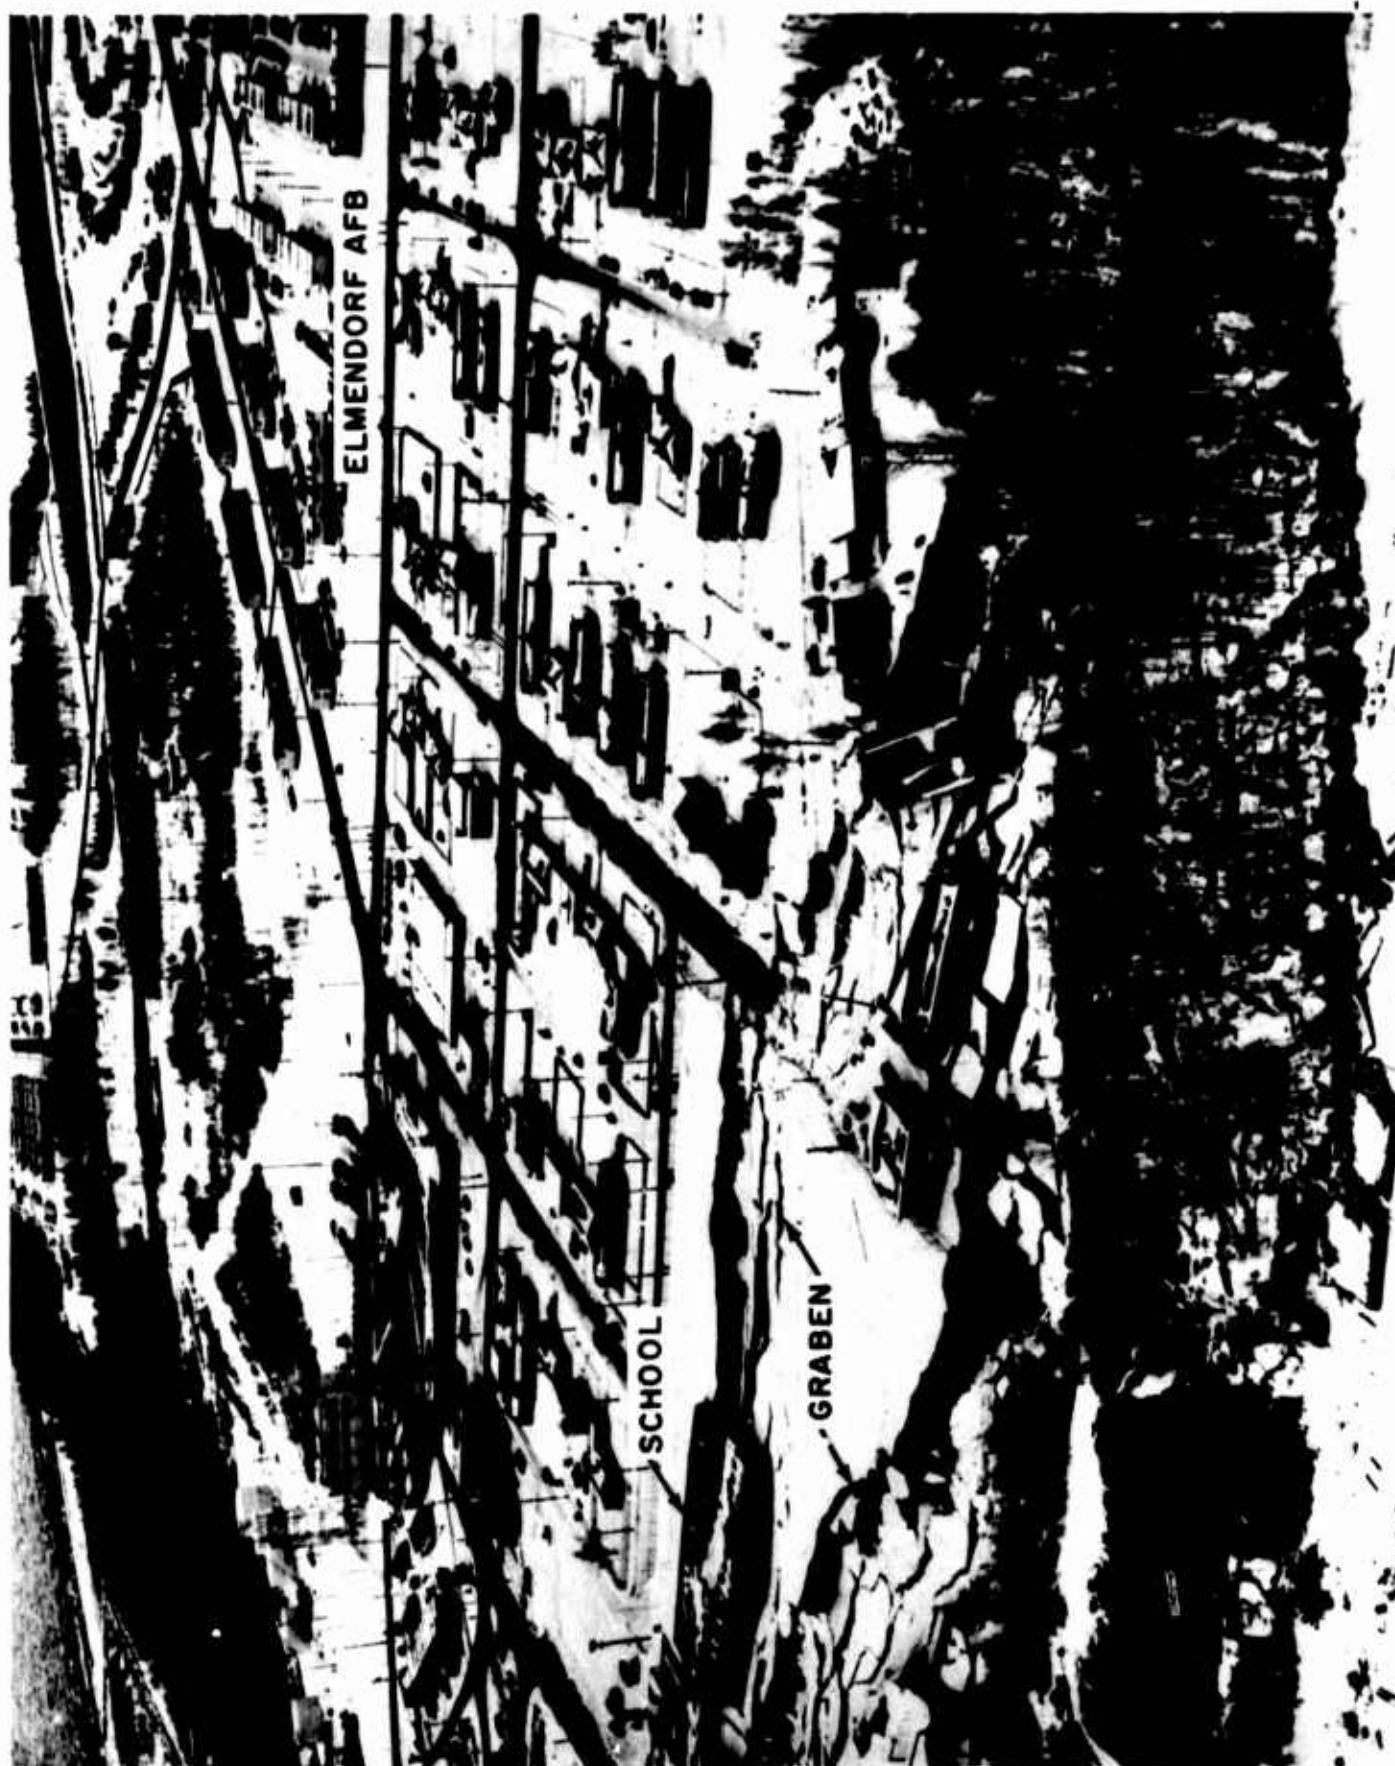
Figure 103. Government Hill Slide (Aerial view of the east end of the slide showing damage to residential buildings)

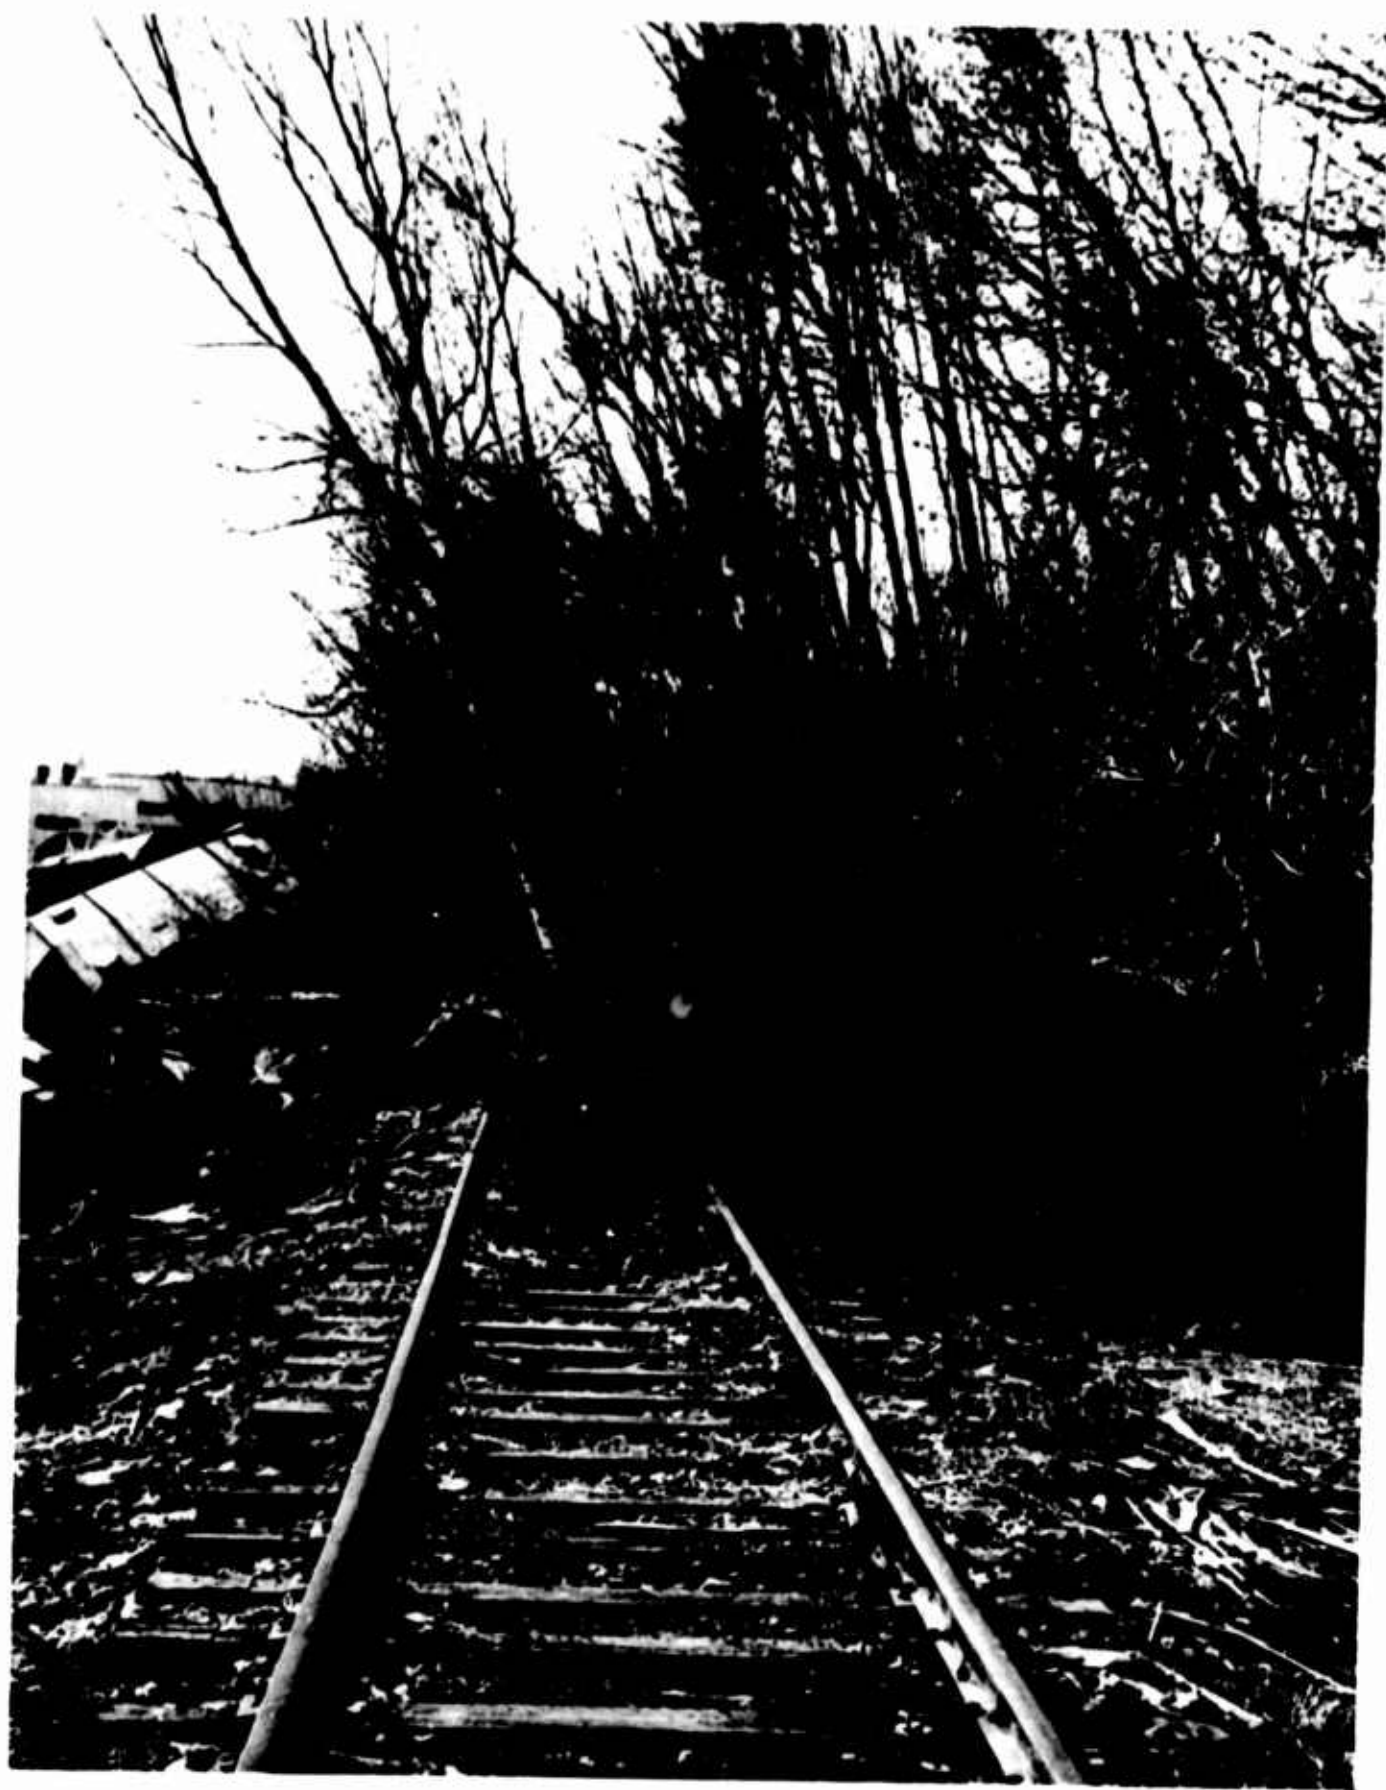
Figure 112. Government Hill Slide (Alaska Railroad track covered by a pressure ridge)

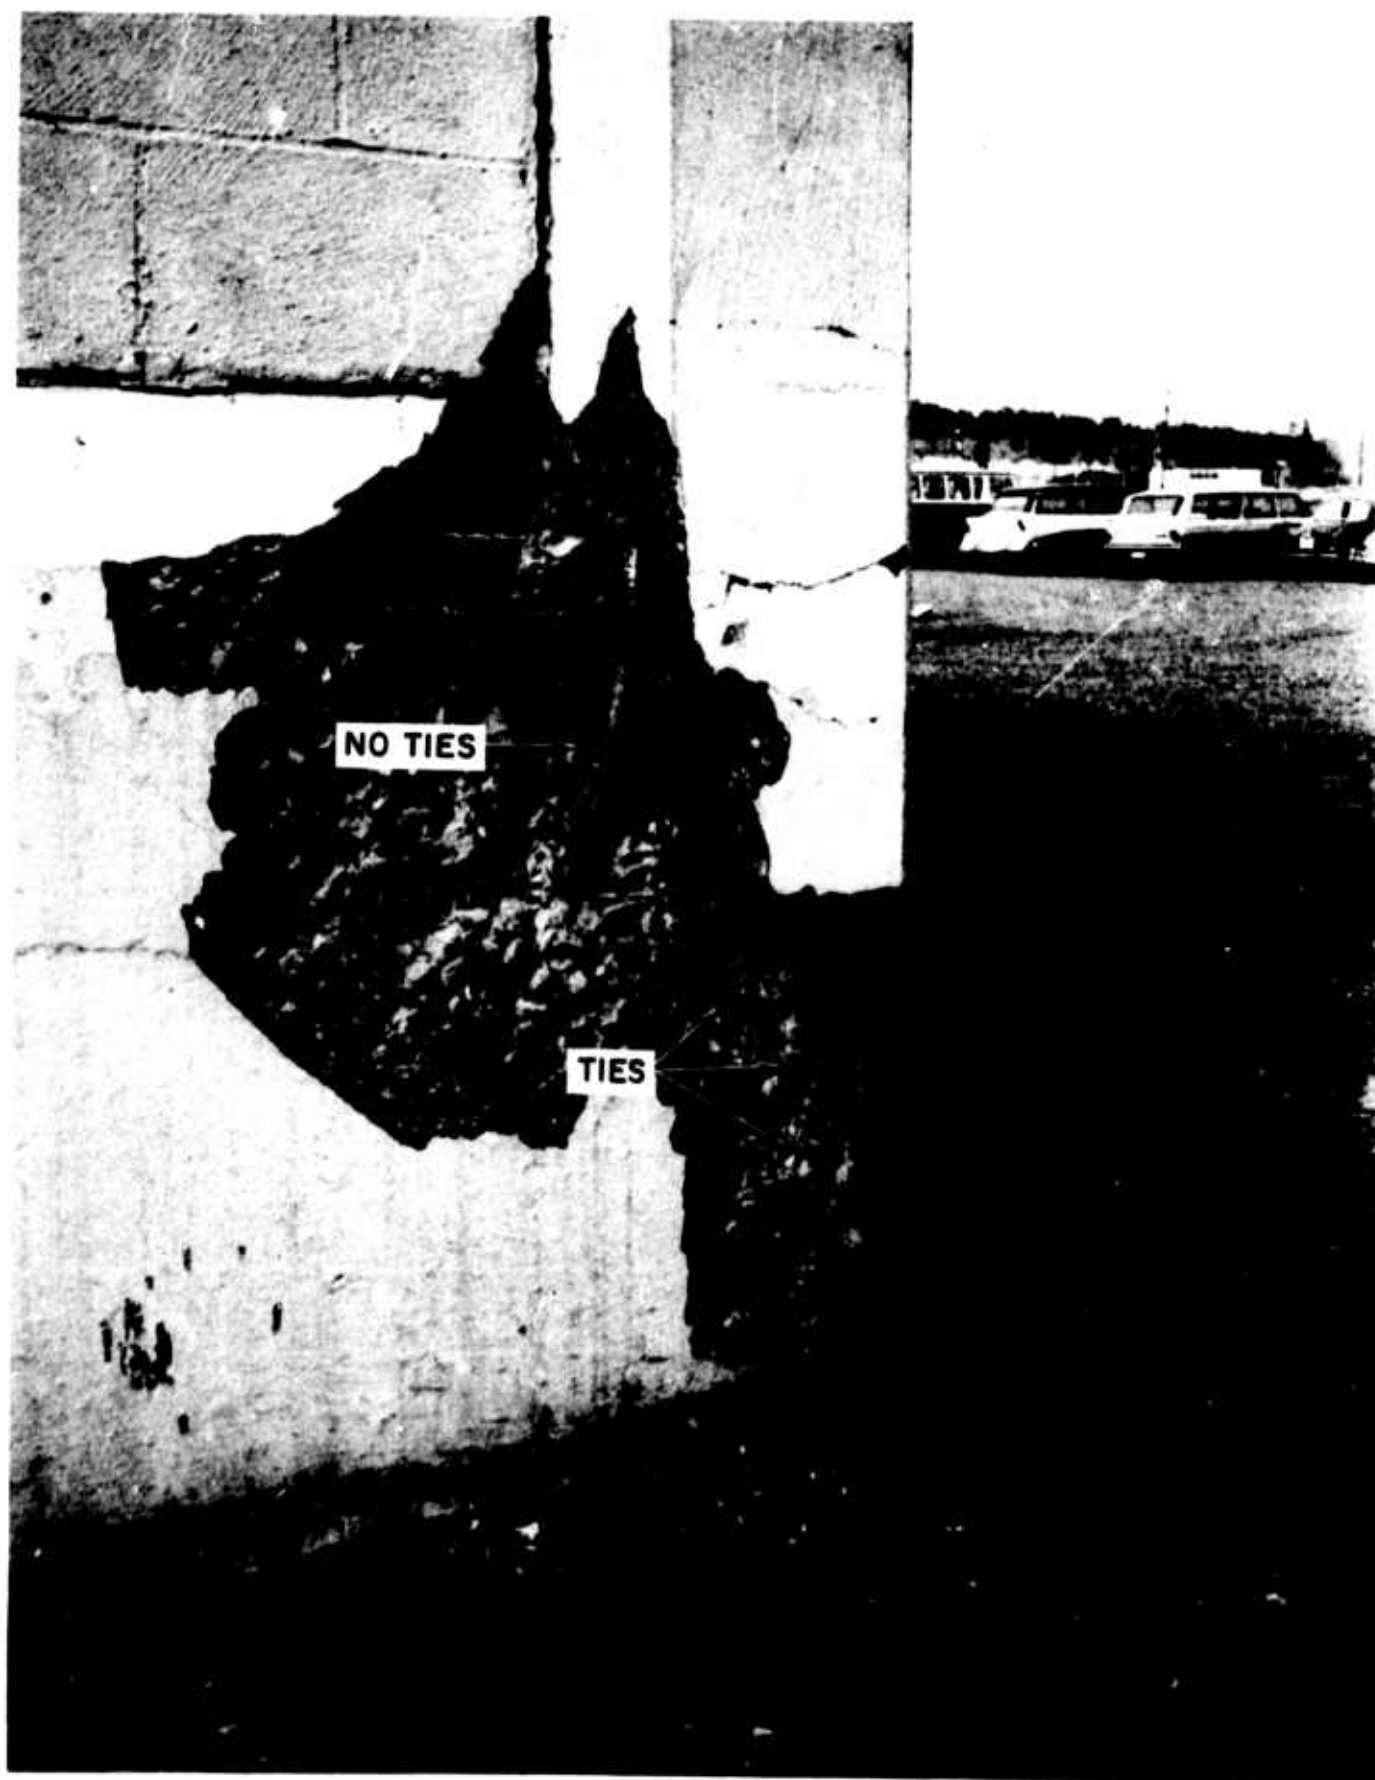
Figure 126. Elmendorf AFB 750-Man Barracks (Column shear failure at first-floor level in northeast corner of Building 31-250. Notice absence of ties in failure zone.)

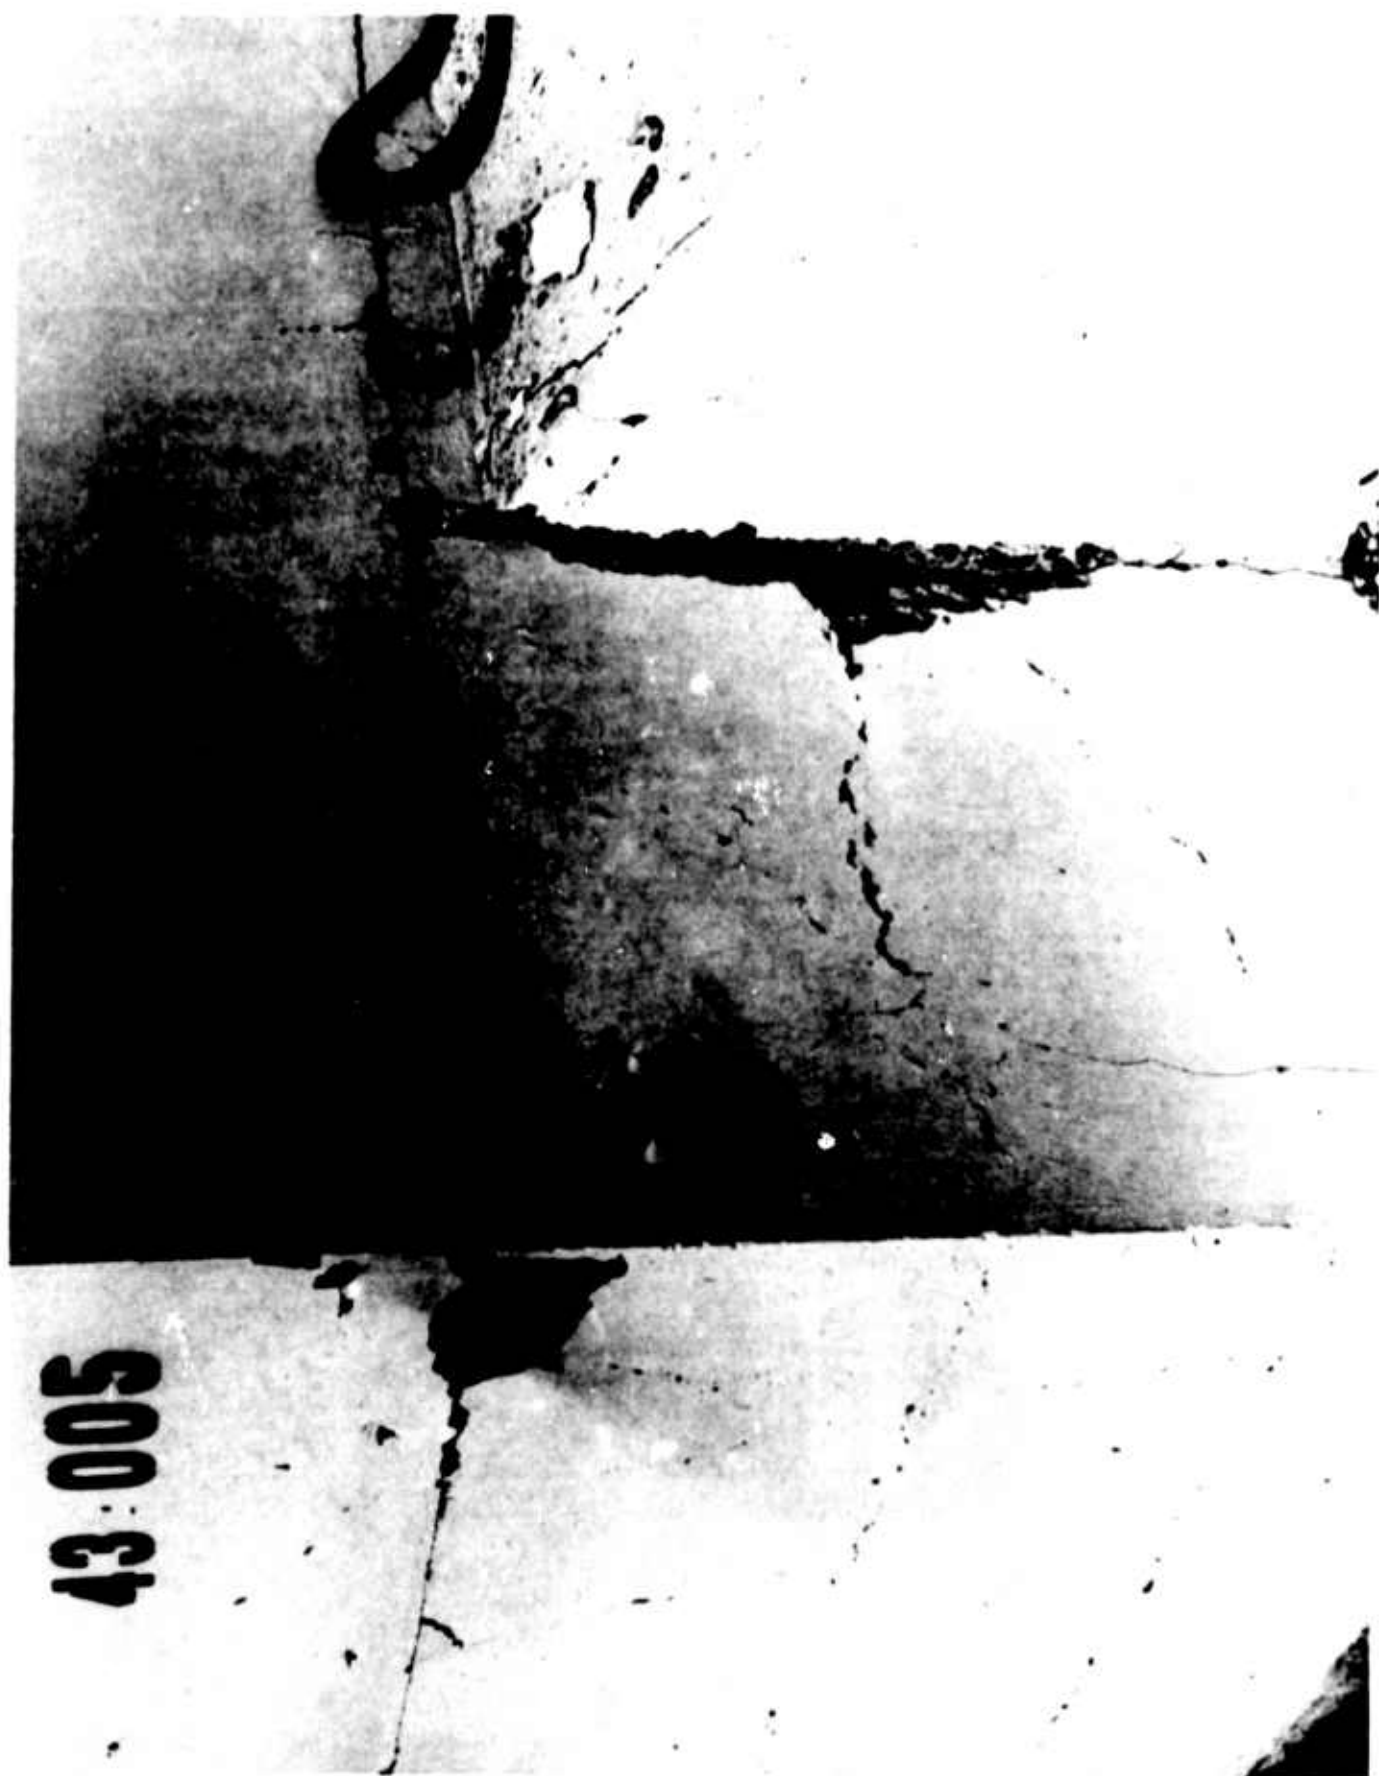
Figure 130. Elmendorf AFB Aircraft Control Tower (Closeup of horizontal crack following a construction joint at southeast corner of tower. Note spalling of paint and concrete.)

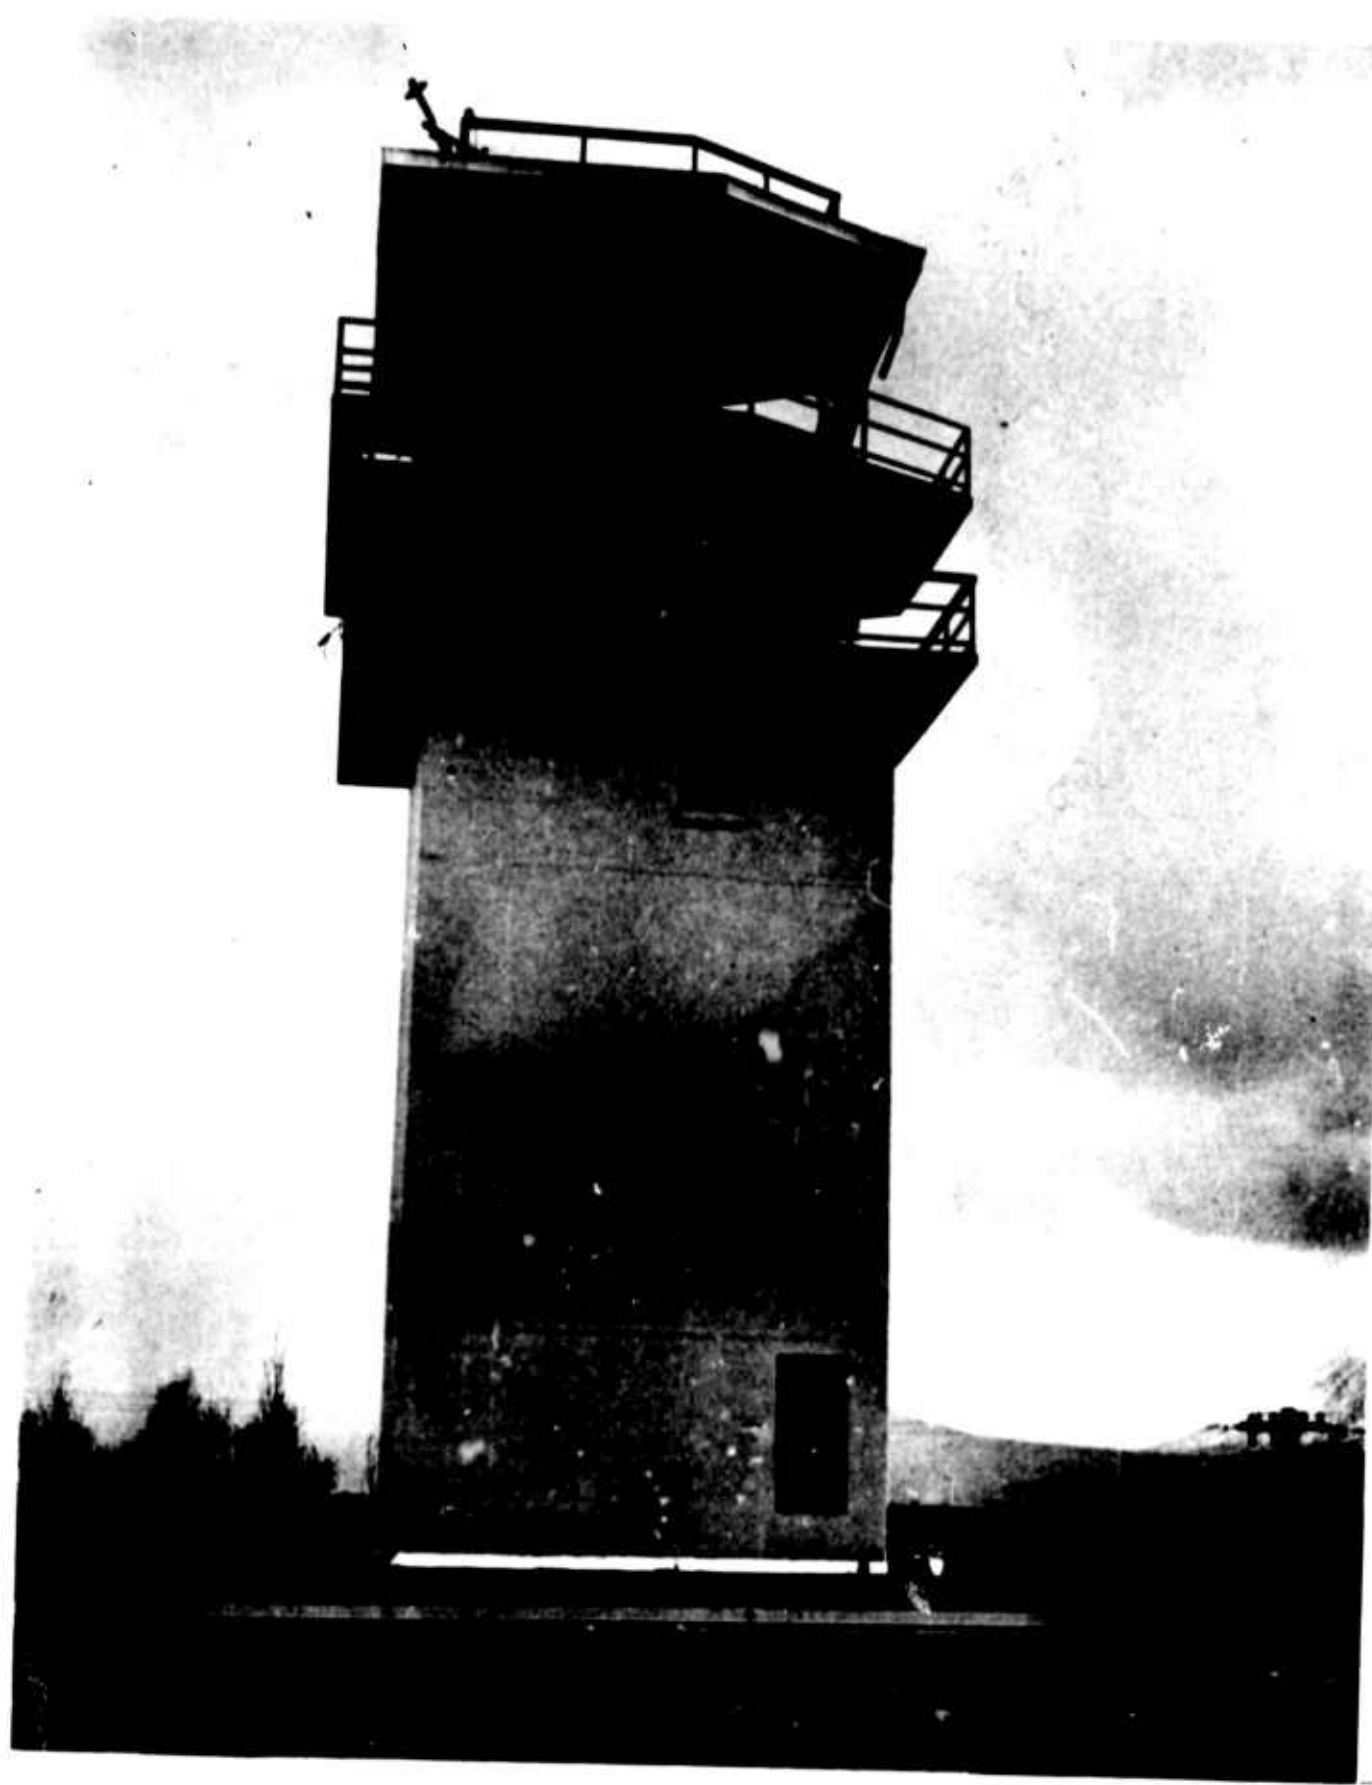
Figure 132. Elmendorf AFB Aircraft Control Tower
(West wall of tower above level of Communications Building roof)

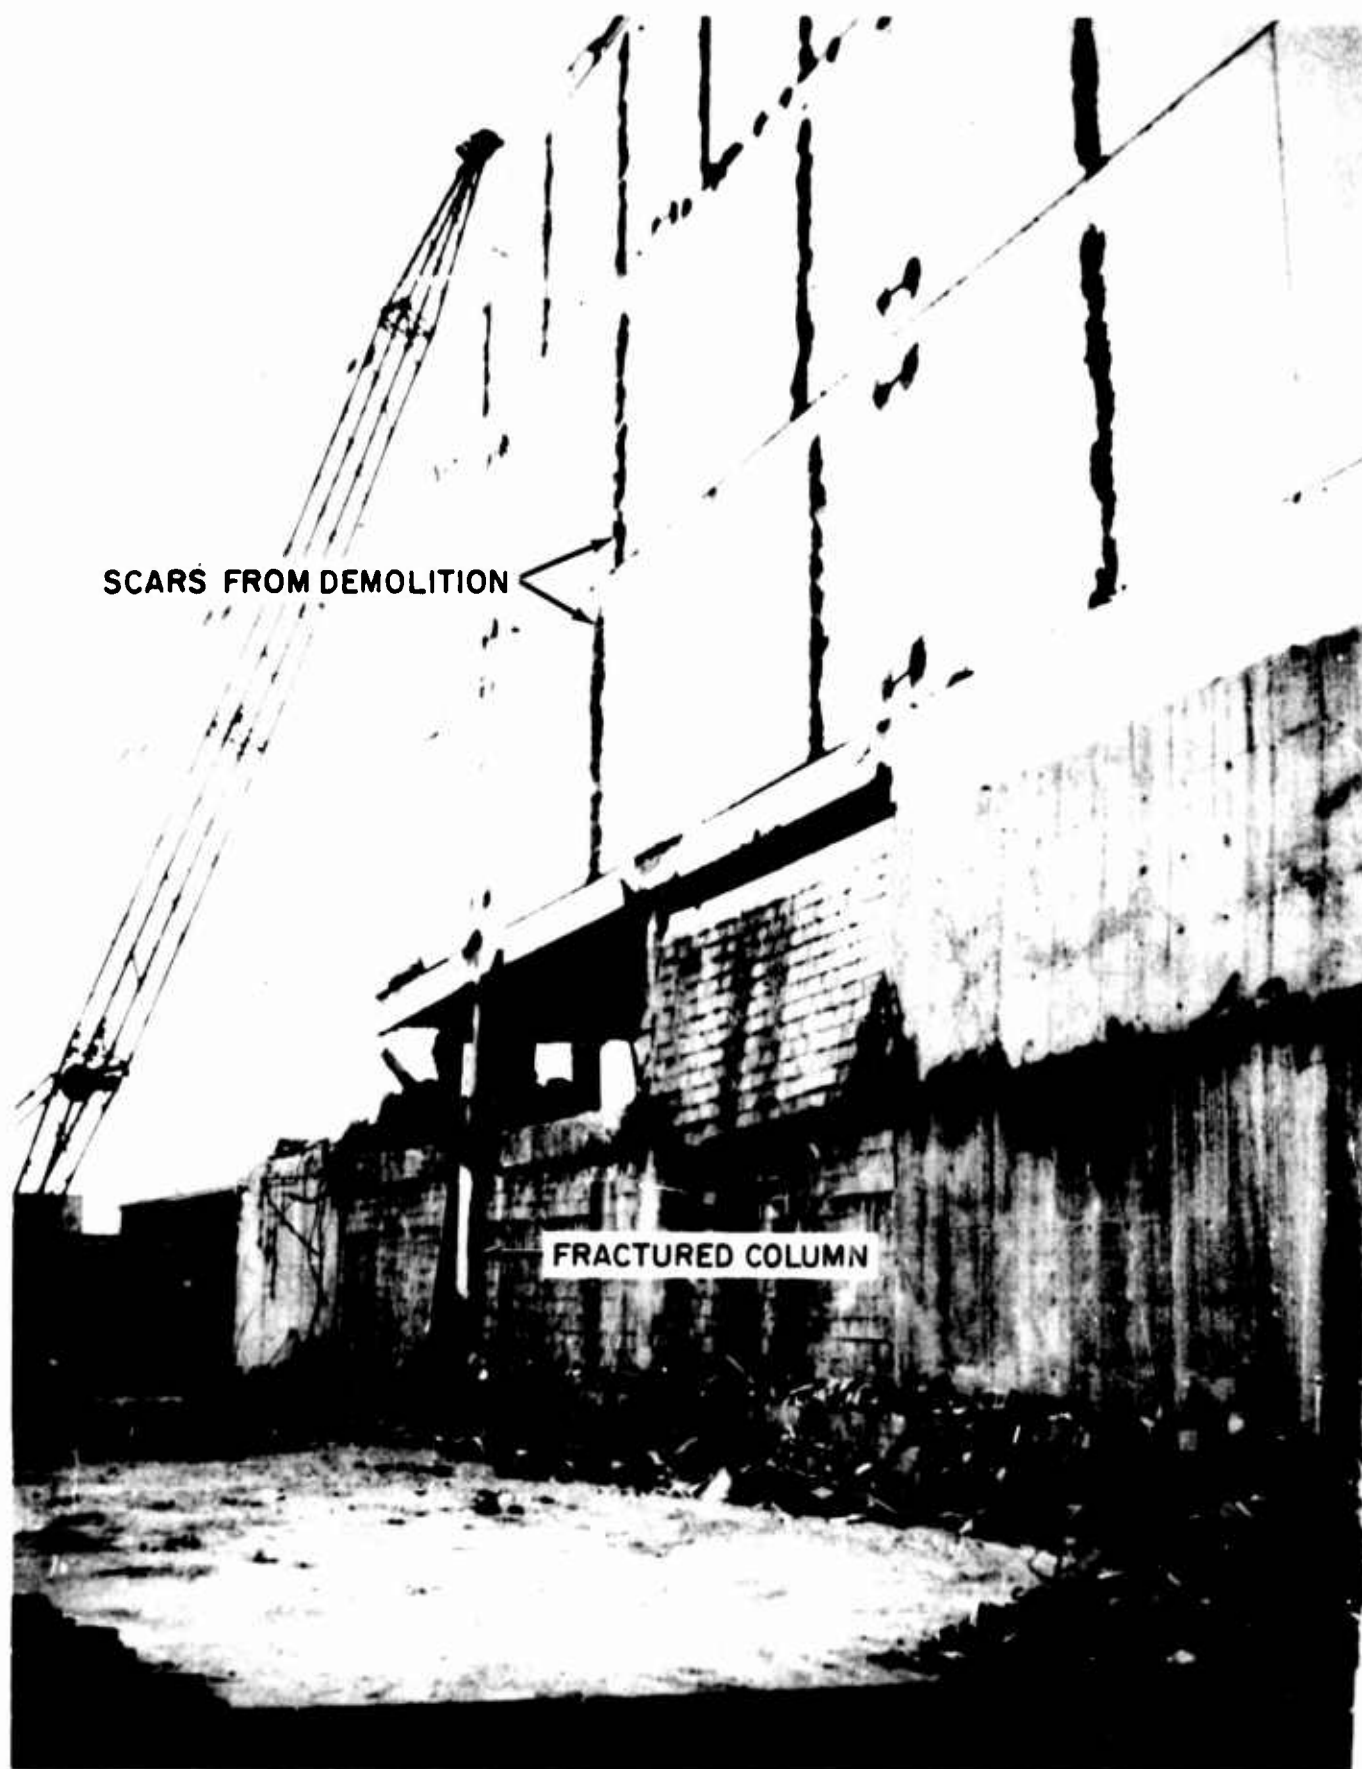
Figure 142. J. C. Penney Building (West side of the structure during demolition showing unseated shear panels and fractured column. Adjacent building has been razed to make room for demolition operations.)

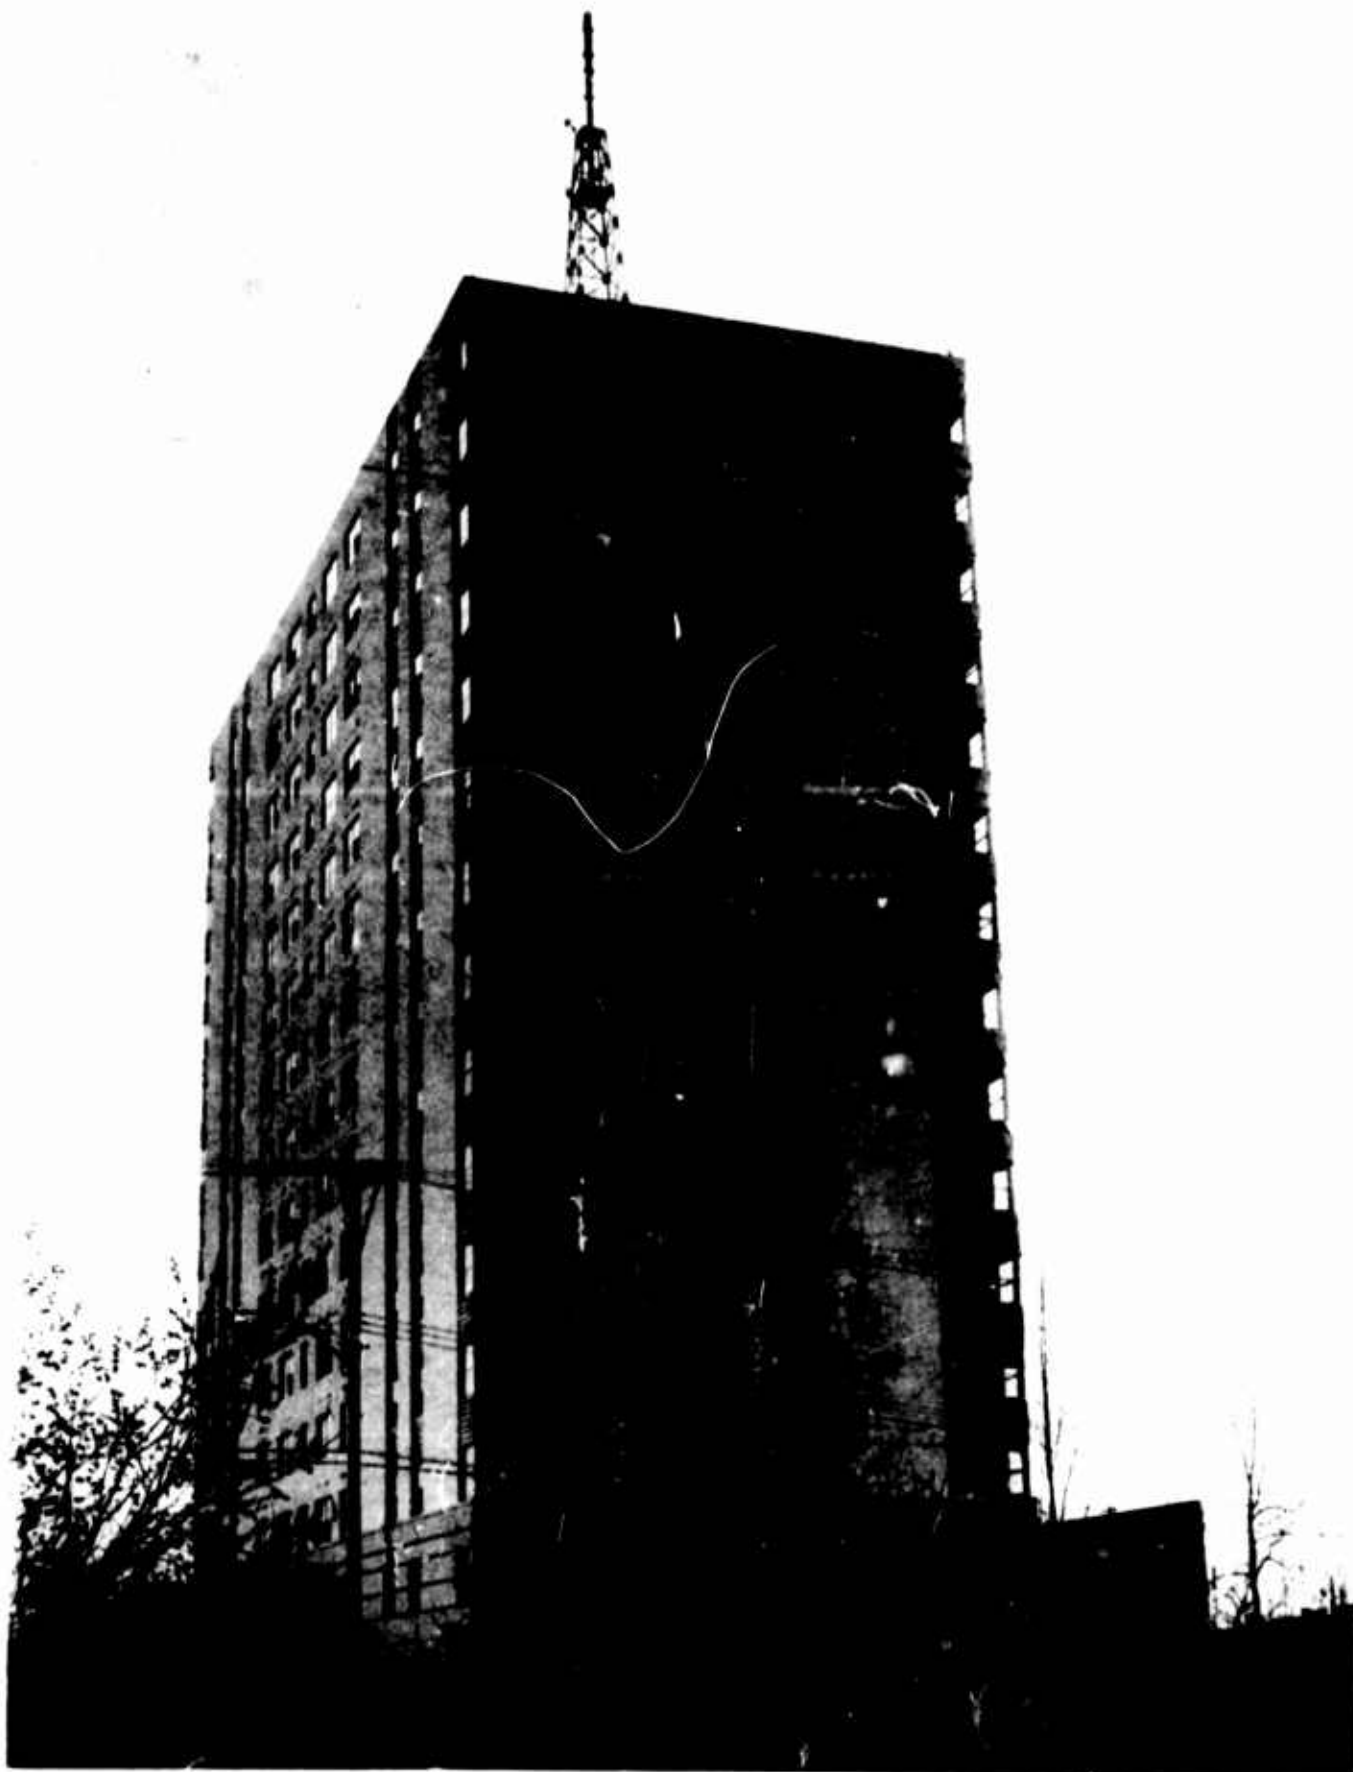
Figure 146. Mount McKinley Building (North side of the structure showing column wall fracture just below the fourth-floor level. TV-radio mast undamaged.)

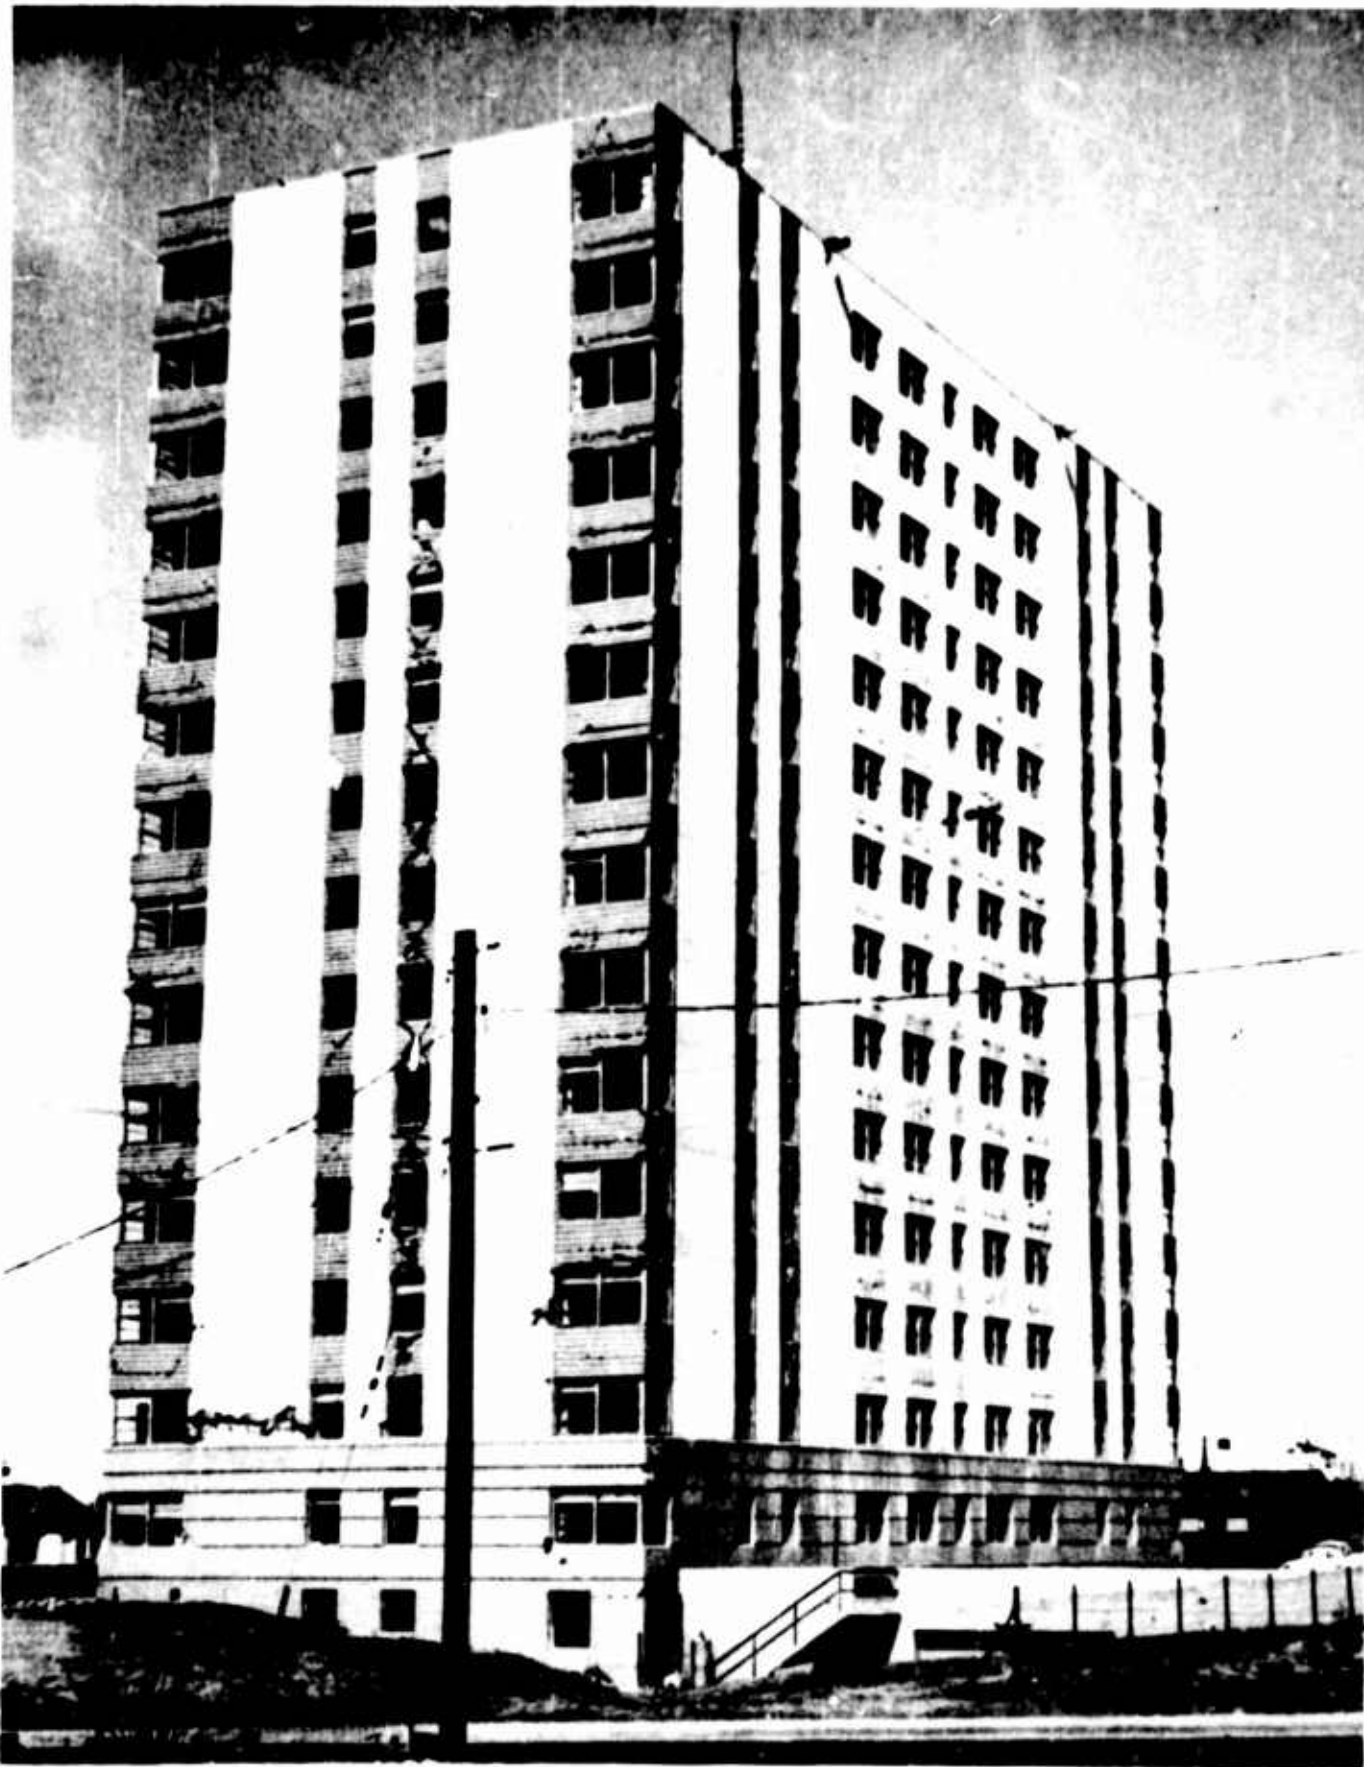
Figure 147. Twelve-Hundred L Street Apartments
(South side of the structure showing column wall fracture midway between the
second- and third-floor levels)

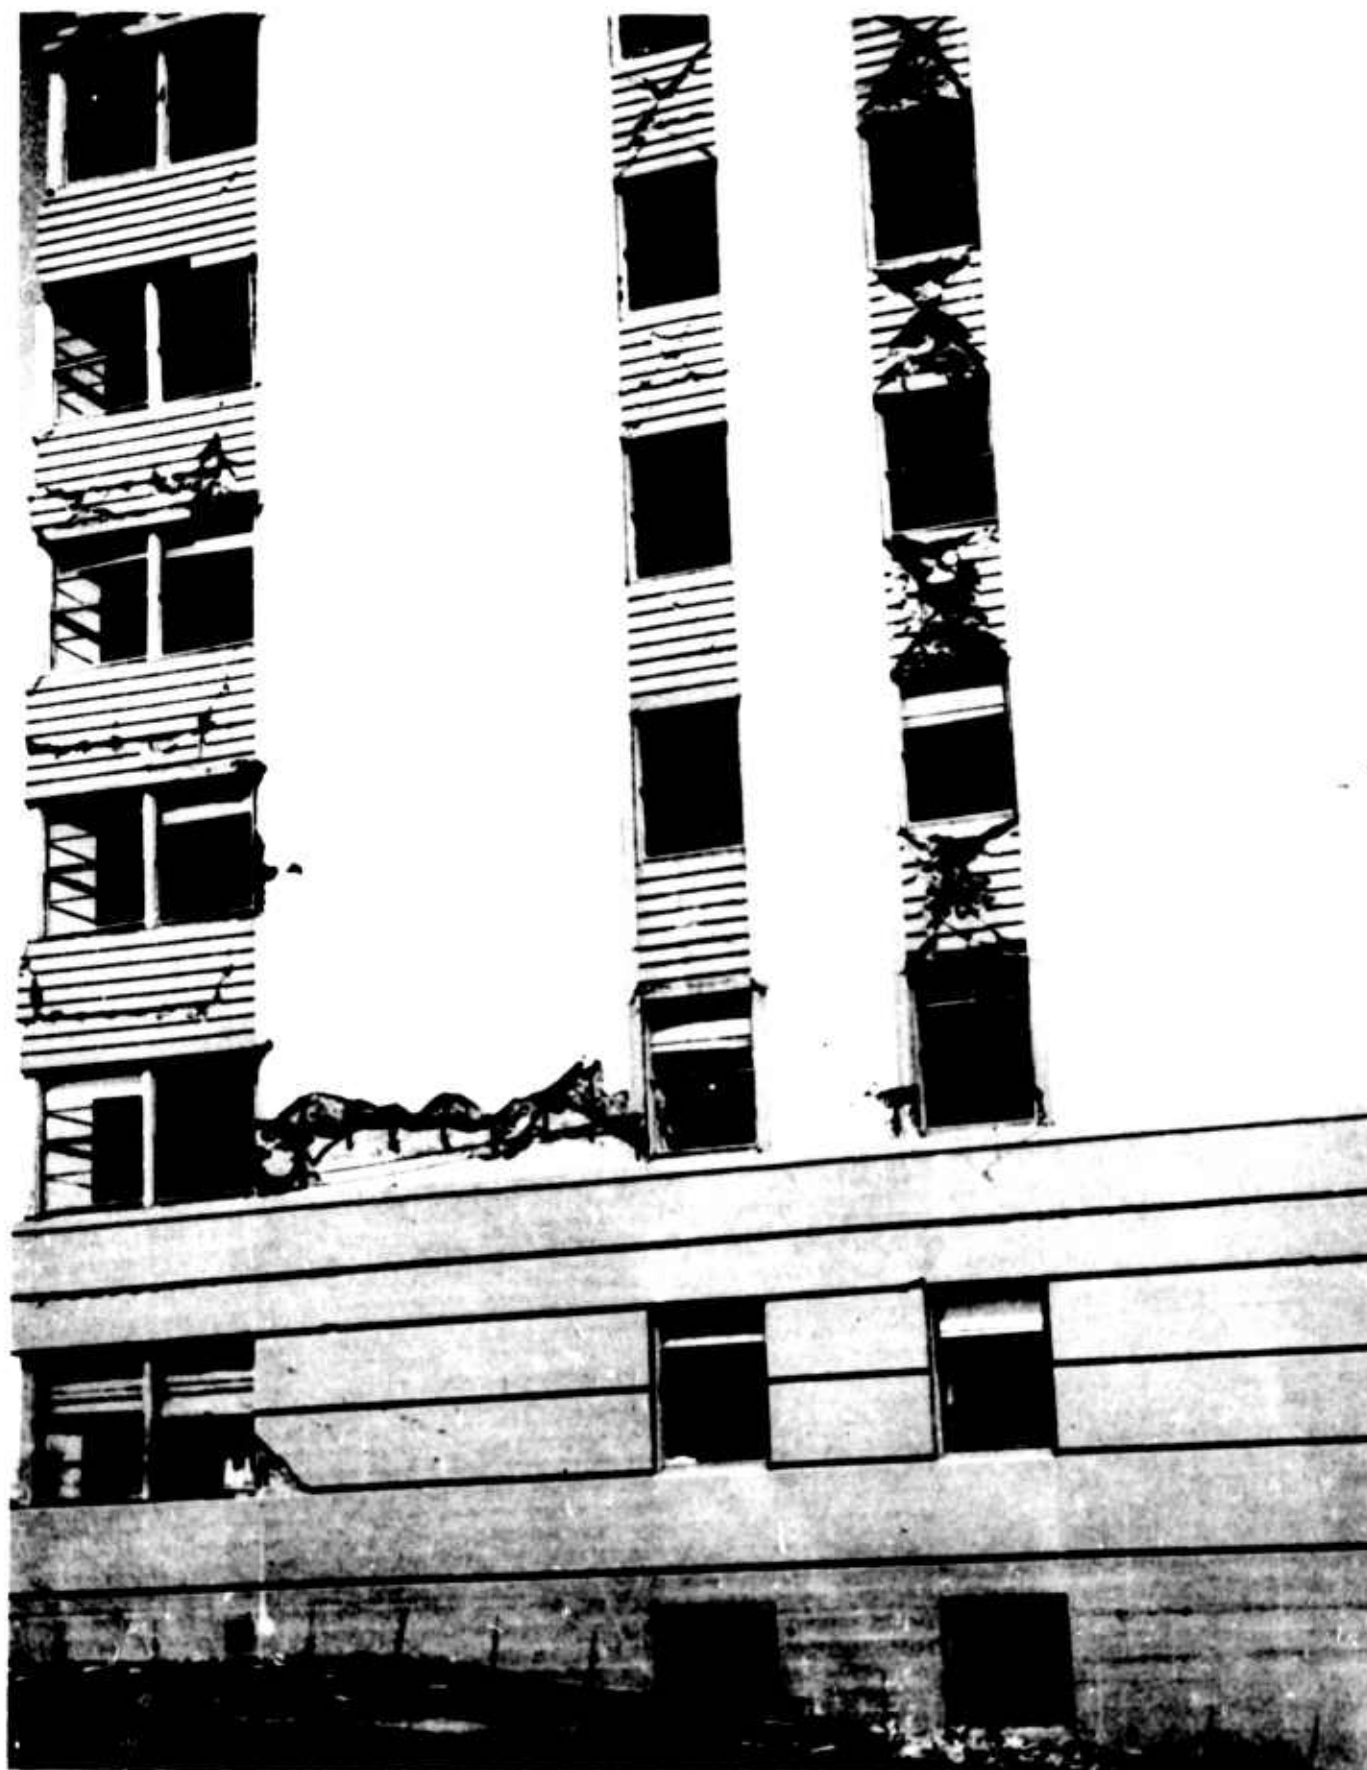
Figure 149. Twelve-Hundred L Street Apartments
(Exterior closeup of column wall fracture)
